Mississauga Fire Station 125
Whole Building Airtightness Report No.2

Test Date: May 13, 2024
Report Date: May 27, 2024

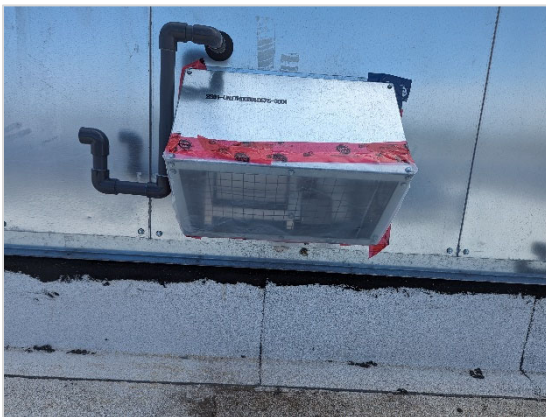
Stage 1 included temporary sealing at the mechanical penetrations through the enclosure from the exterior (Refer to Figure 2), exterior doors were closed and interior doors were opened. All plumbing penetrations were filled with water and all mechanical penetrations were sealed—including dampers. Following this for Stage 2 testing, the temporary seals at the mechanical penetrations were removed, while exterior and interior door configurations remained unchanged from Stage 1. Throughout both stages, the HVAC system remained switched off. A summary of openings and their condition for both stages are outlined below:

Figure 2: Example of exterior penetration sealing at make-up air unit

Temporary air sealing was carried out by the Contractor (Gateman Milloy) and BELi prior to the test. This temporary air sealing was removed by BELi for the Operational Test.

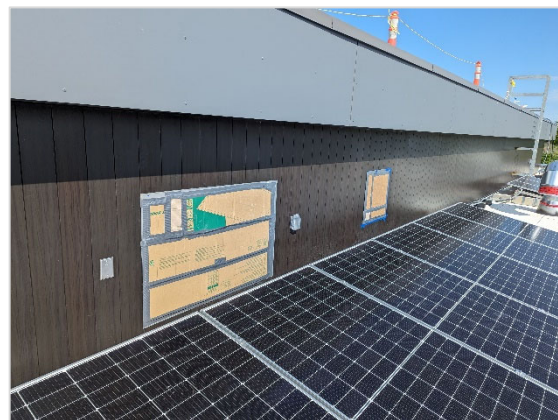
Figure 3: Example of exterior penetration sealing at exhaust ducts

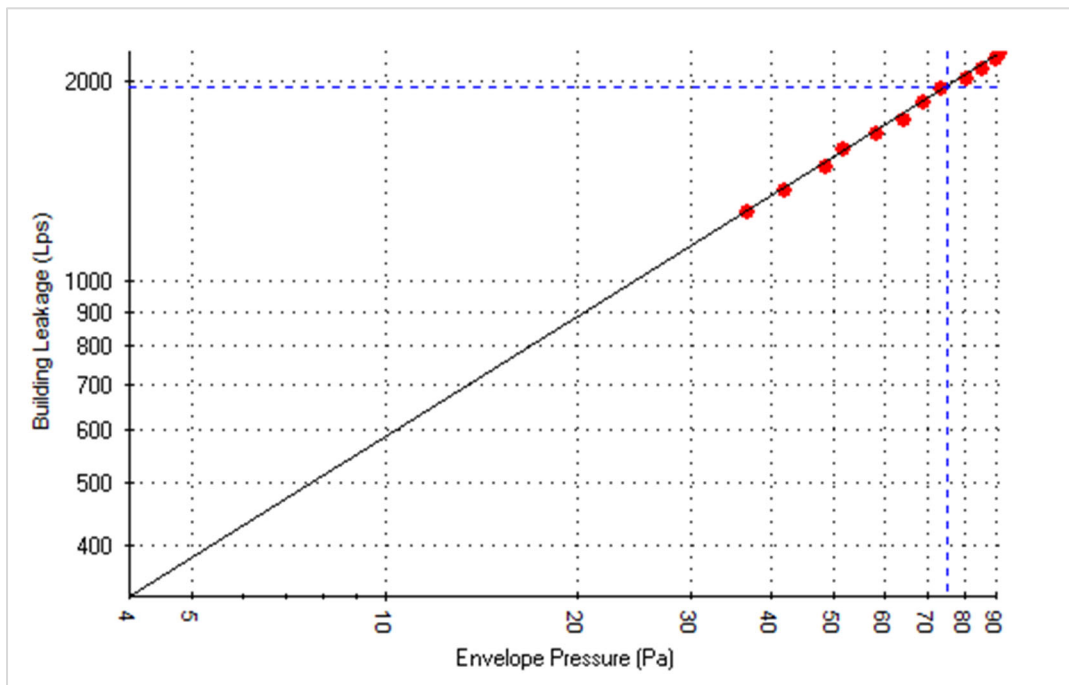
TEST No.3: Operational Depressurization		
Test Pressure (Pa)	Flow Rate (L/s)	Ring
29	-89.71	Open
30	-88.71	Open
29	-83.96	Open
29	-79.79	Open
28	-72.63	Open
28	-68.04	Open
30	-63.44	Open
30	-57.58	Open
29	-50.73	Open
29	-47.85	Ring A
30	-41.25	Ring A
29	-35.97	Ring A
Wind Speed (m/s)[Direction]: 0.7 [WSW]		
Temperature(C): Pre: 21.1 Post: 21.8		
Baseline Pressure (Pa): Pre: 1.2 Post: -0.9

Operational Depressurization Test
